REPLACEMENT AIRCRAFT PARTS CO.

Service Letter

Service letter Number	Issue Date	Revision	Revision Date
RASL-002	10/26/2006	В	6/11/2009

Subject: Pneumatic pump vane inspection without S.M.A.R.T Stick

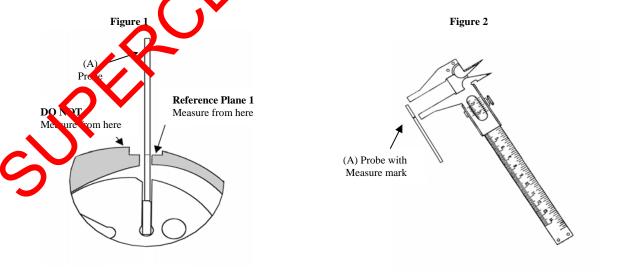
- Using a felt tip marker, mark the probe evel to the plane (Reference Plane 1) at which the inspection port cap screw washer comes into contact with the pimp cavity. (See figure 1)

- Remove the probe from the inspection point. Measure the distance from the triather was inserted into the pump to the mark that was made with the felt tip marker. (See figure 2)

- If the distance measured (11/16 (.647") or greater the pump should be **removed** from service. If the distance measured is less than 11/6" (.687") the pump may be **returned to service** pending that the next inspection is accomplished after 100 hours time in service or at the next annual inspection. Re-install the cap so ew and washer (MS35338-43) and torque to 14 inch lbs.
